Survey: Sample Thermographic Investigation	Location: Monmouth Street, Bath	Date: 25 th February 2009
Client: Philip Jennings Chartered Surveyor

Location	Junction of Chapel Row and Monmouth Street, Bath)
Equipment	Flir B360

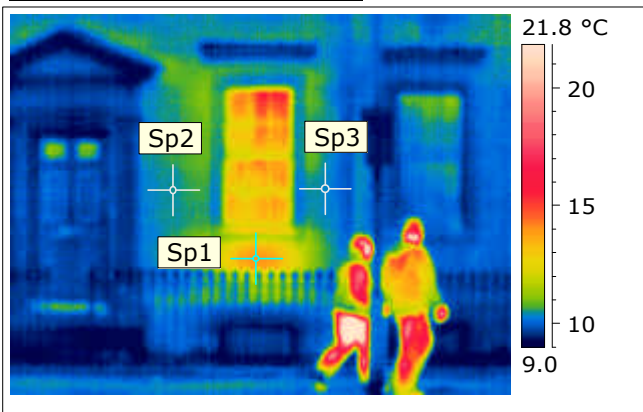
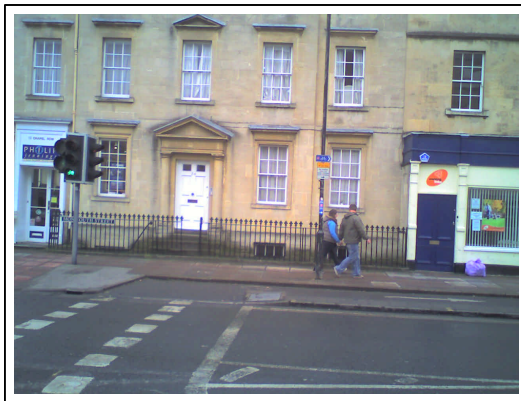
Sp1 Temperature	14.0 °C
Sp2 Temperature	10.6 °C
Sp3 Temperature	10.3 °C

Requirement: Survey lower front elevation of property on Monmouth Street, Bath
Construction: Regency building in solid Bath Stone with sash windows and stone sills.
Elevation: South / South West fronting busy main road.
Weather Conditions: The thermographic image was taken at mid day. The weather was dull with low cloud and high humidity, but no rain.
Temperature: 10°C
Humidity: Very High
Analysis: The spot temperatures, Sp2 and Sp3 indicate the external wall has a surface temperature of just over 10°C. However the area beneath the stone sill is showing a higher reading of 14°C or higher. This indicates that there is an anomaly with the main surface area of the wall.

1. As the window above the sill is also showing a high reading it may be that there is a hot radiator directly below the window on the inside which is being transmitted through the wall.
2. The increase in heat could be highlighting a damp problem below the sill. Damp in this location could be the result of the stone sill having little or no water drip resulting in rainwater running down the wall rather than dripping away.

Carry out further investigations to identify route cause.

1. Identify whether a radiator is present.
2. Visibly check for water drip. Use of a damp meter on the external wall to confirm existence of damp.

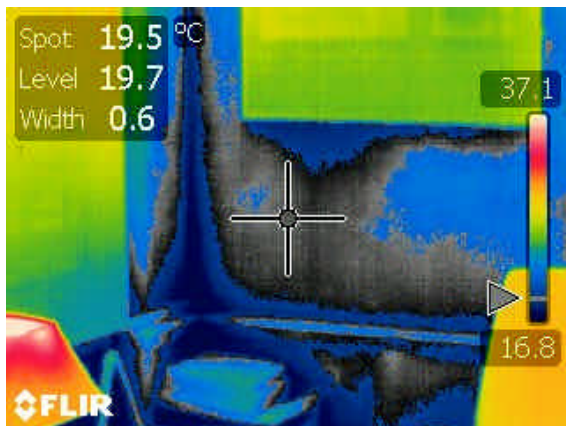
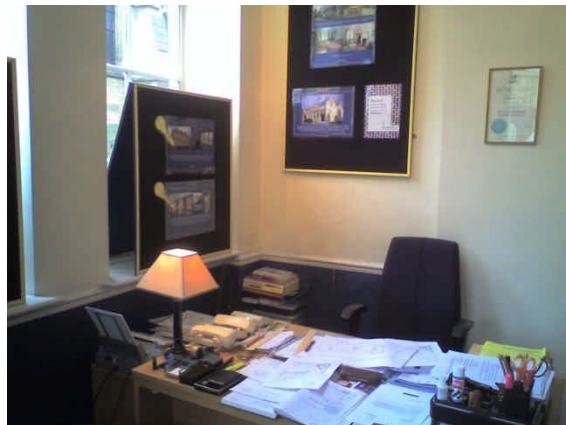
Investigating the internal wall of an office it was clear that damp had penetrated the wall and was advancing along the internal wall.
 Utilising an Isotherm we are able to highlight the extent of the damp problem.
